HABITAT EROSION PROTECTION ANALYSIS

Missouri National Recreational River
Nebraska and South Dakota

April, 2000

US Army Corps
of Engineers
Omaha District

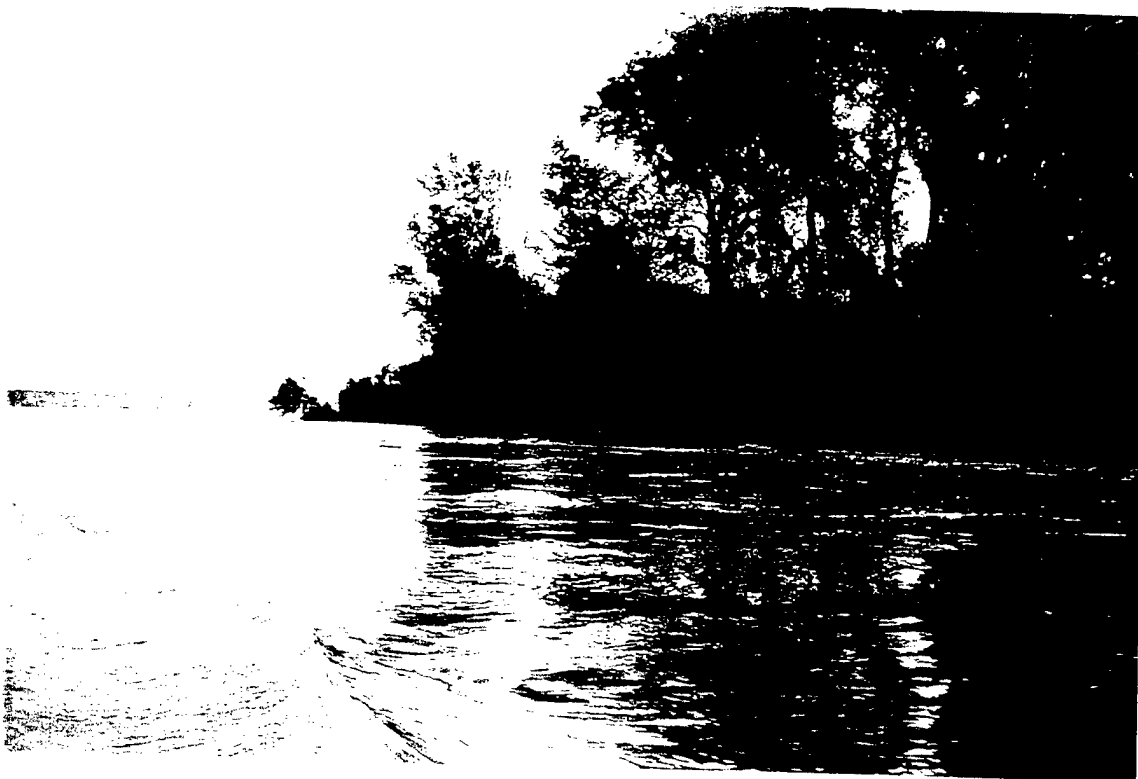
Photo 1. Wooded point of Site A1 that could benefit from bank protection. An eagle nest was documented deep within the wooded grove during the spring, 1999.

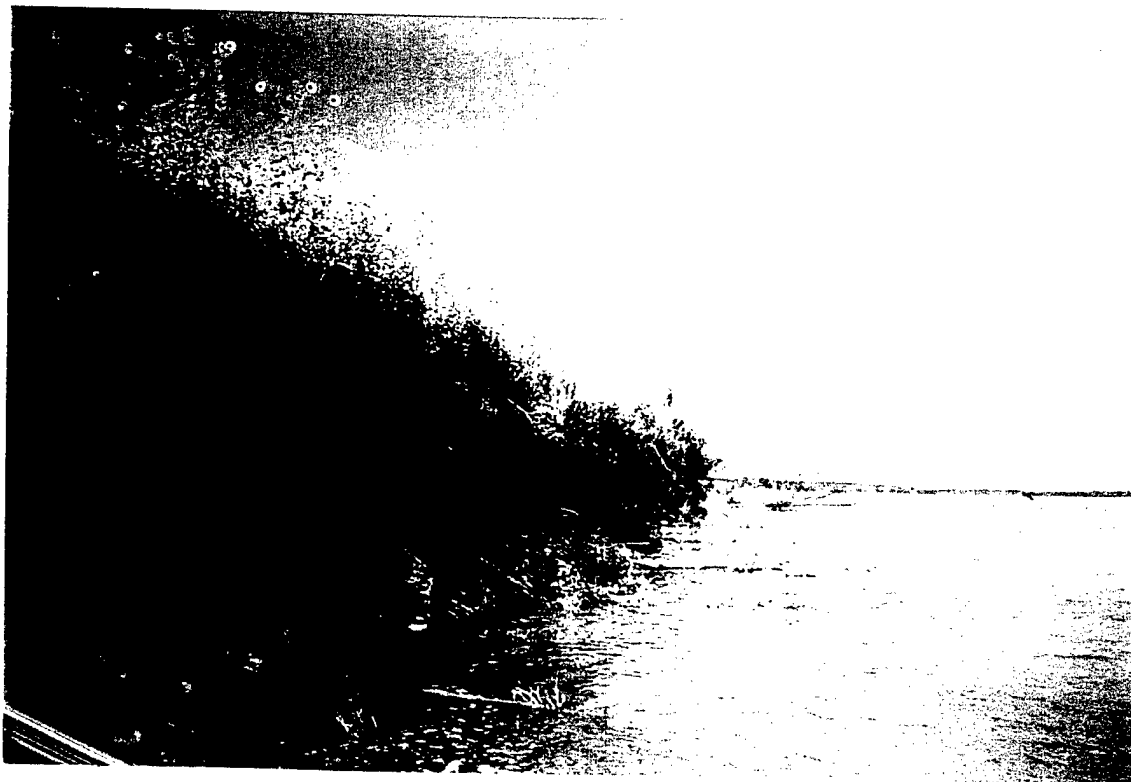
Photo 2. Looking upstream from wooded portion of Site A1 at eroding cropland. This portion of the eroding site is approaching equilibrium.

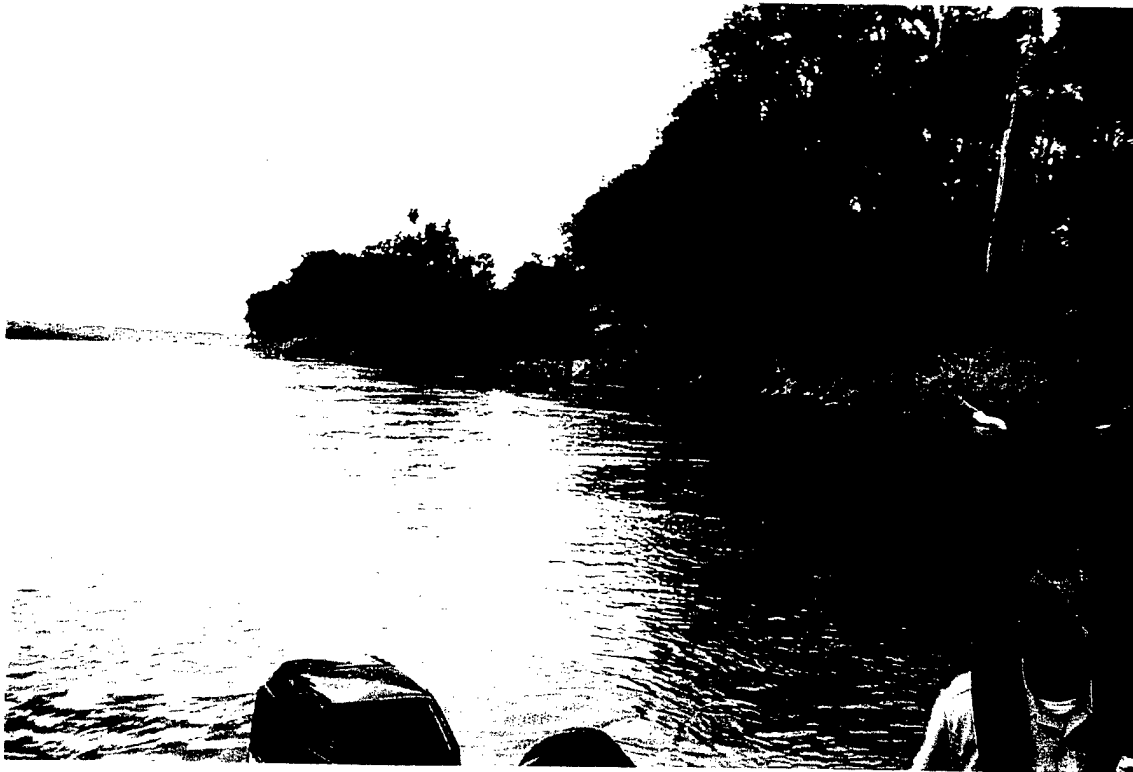
Photo 3. Site A2 looking upstream. Note fallen tree with root wad near shore.

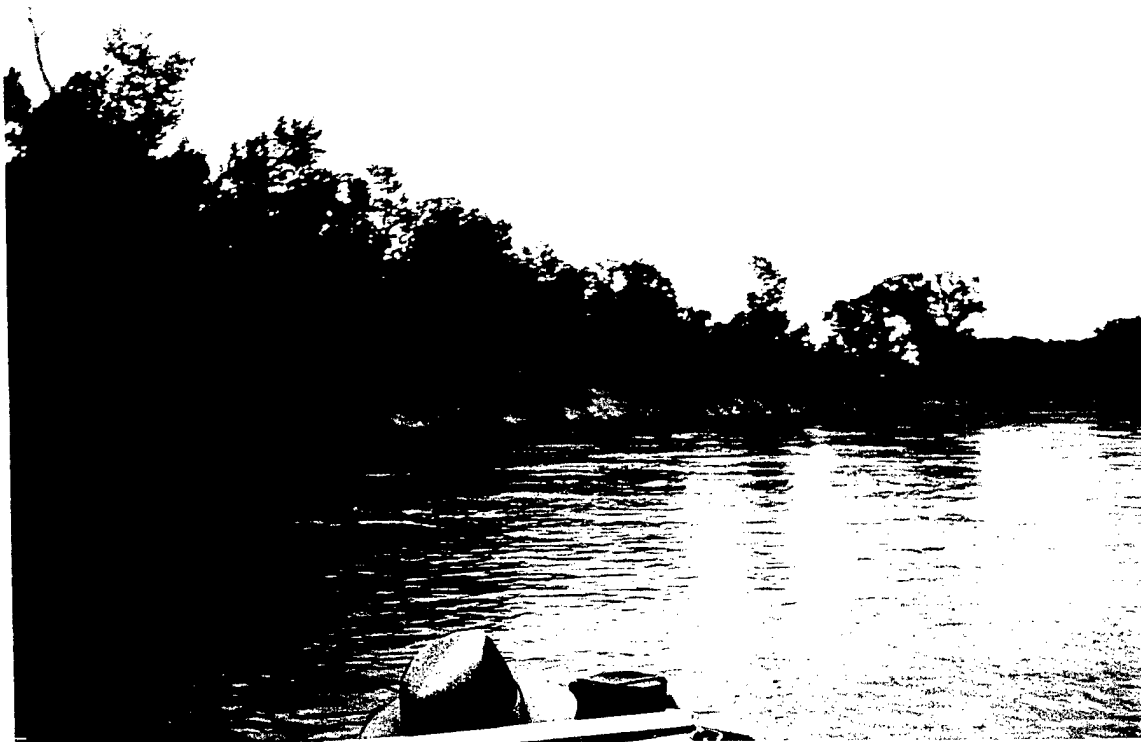
Photo 4. Looking downstream at Site A2. Note overhanging turf.

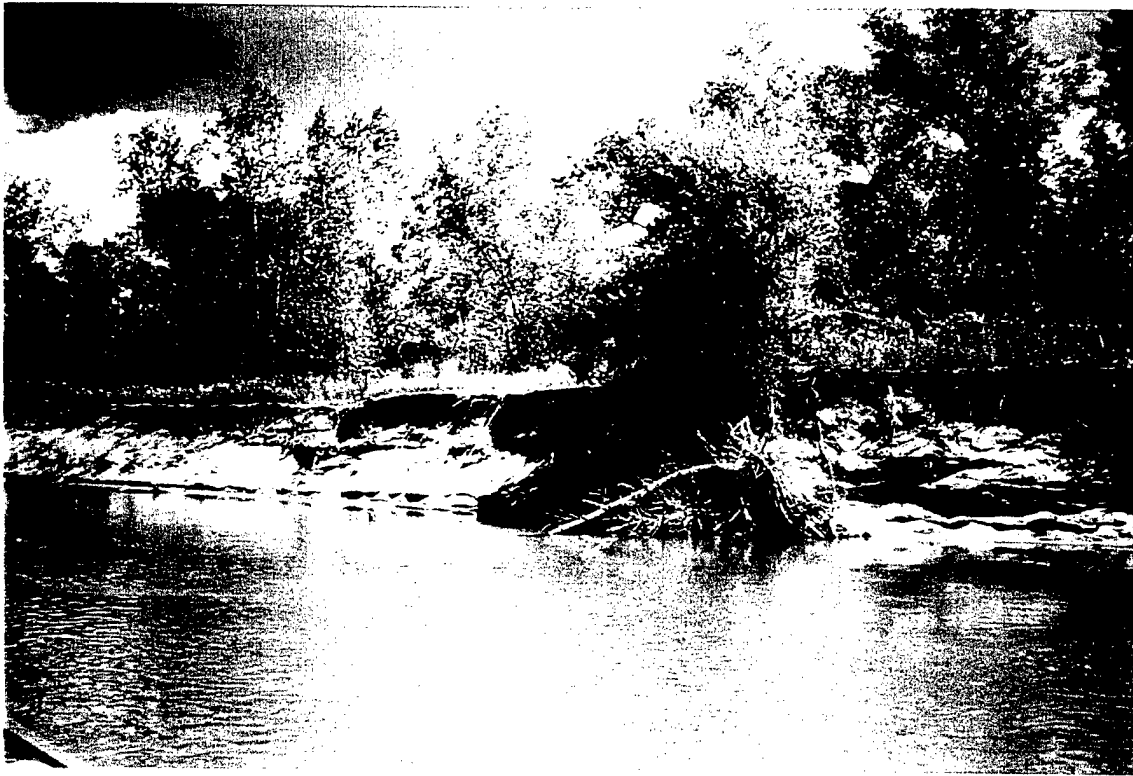
Photo 5. Site A3. Note "sugar sand" soils and fallen tree with root wad.

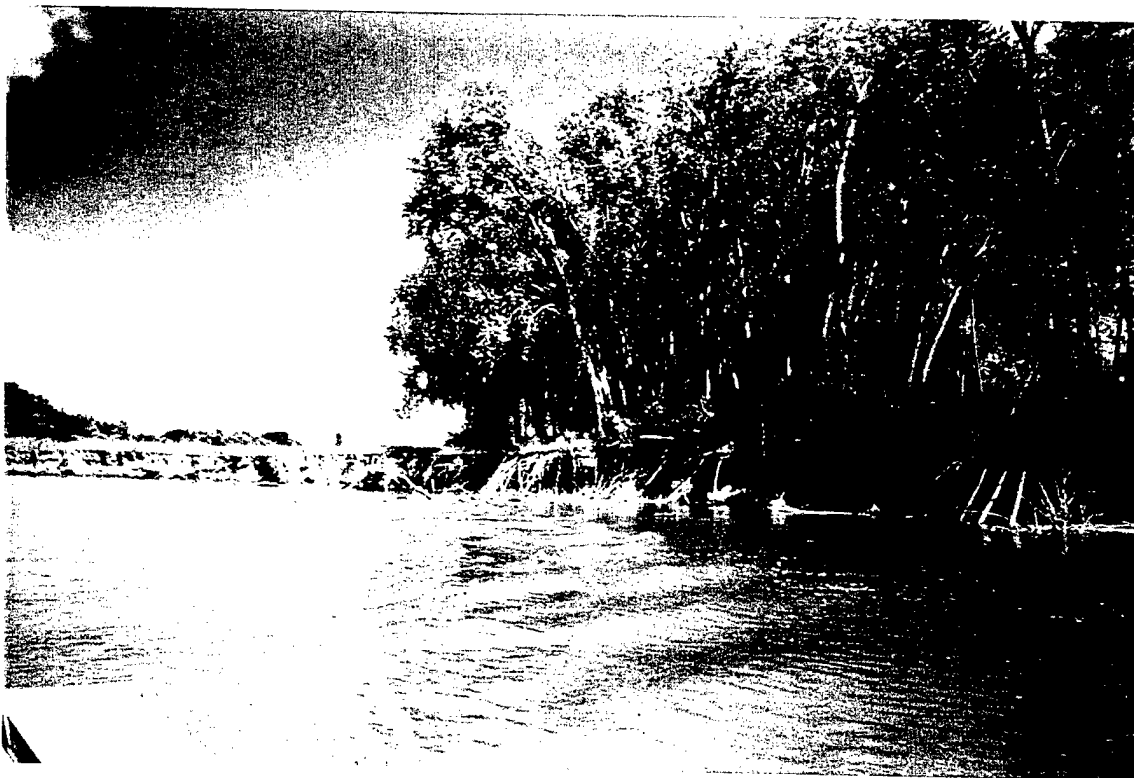
Photo 6. Site A3, looking downstream at eroding grove of trees. Note fallen trees and overhanging turf.

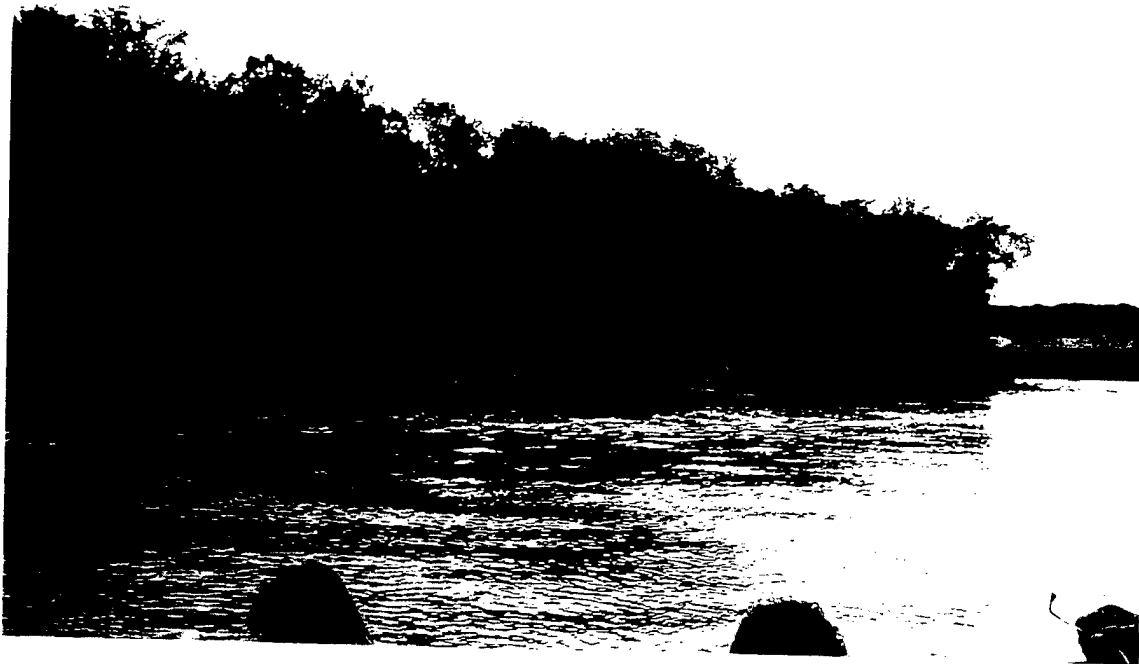
Photo 7. Myron Grove, Site B1. Mature grove of trees eroding over "sugar sand" soils.

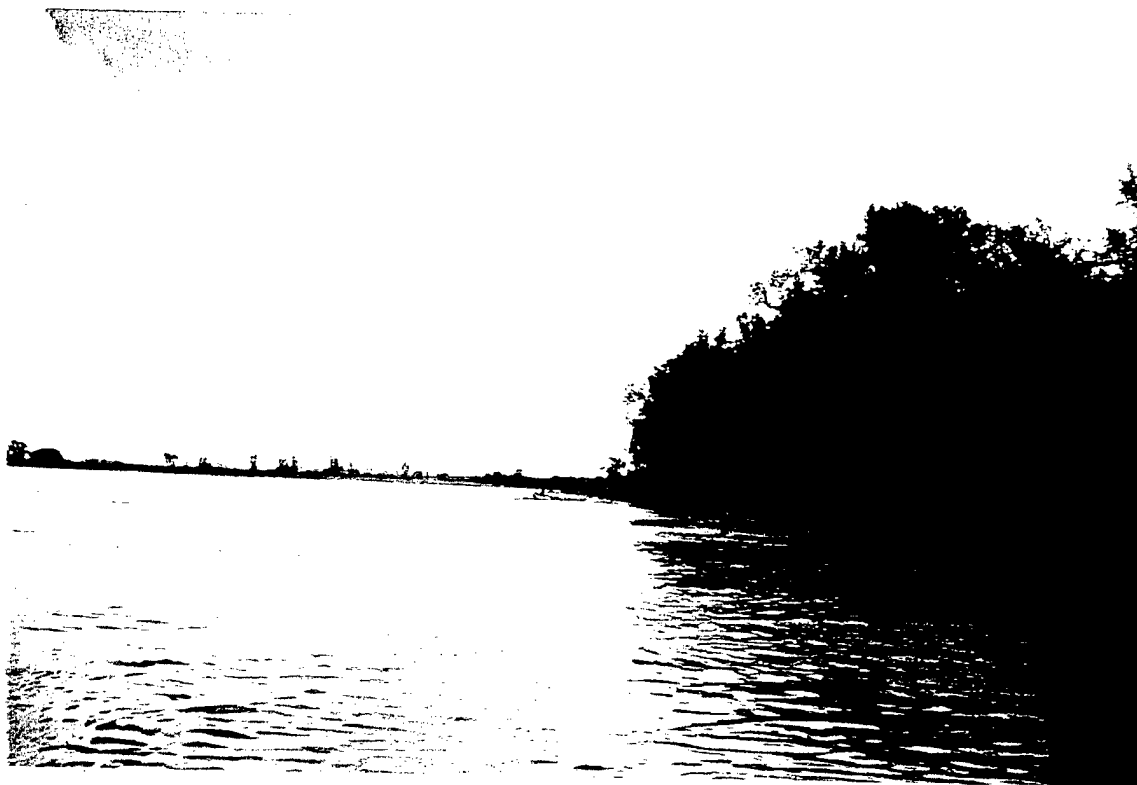
Photo 8. Site B1. Note several fallen trees with turf and root wad along shoreline.

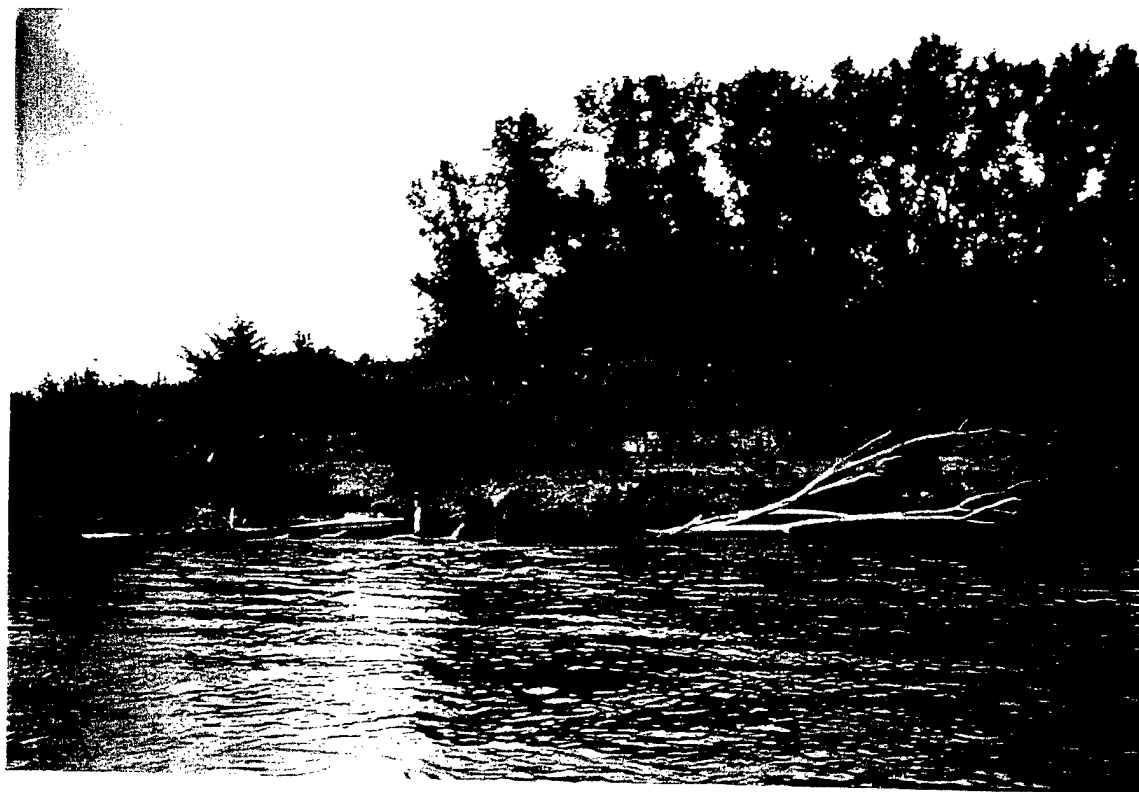
Photo 9. Clay County, Site B2. Erosion of shrub / tree complex.
